BALCONY AND ROOF RAILINGS AND THE CODE: MAINTAIN, REPAIR, OR REPLACE?

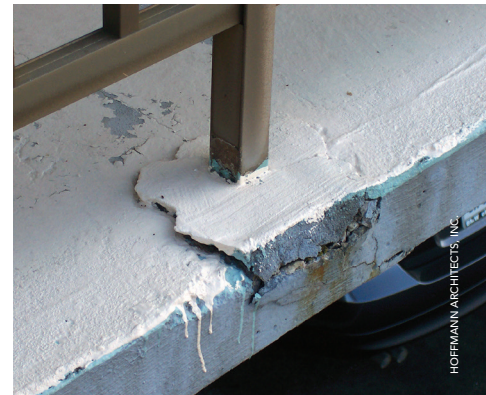
↑
Railing corrosion causing cracks and spalls at post-slab interfaces.

positioned post sleeves, particularly those without protective coatings, can undergo galvanic corrosion from contact with concrete reinforcement, and resultant expansion forces can crack or spall the concrete.

Gaps at the post-sleeve-slab interface, if not properly finished, can allow water to penetrate the concrete, bringing deleterious chlorides, crevice corrosion, and harbored water subject to freezing and thawing stresses. Around post sleeves, gypsum-containing setting grout may absorb water and swell, causing the concrete to crack.
