# preventing and treating failure IN GLAZED CURTAIN WALL SYSTEMS

**BY RUSSELL M. SANDERS, AIA, AND  
CRAIG A. HARGROVE, AIA, LEED AP**

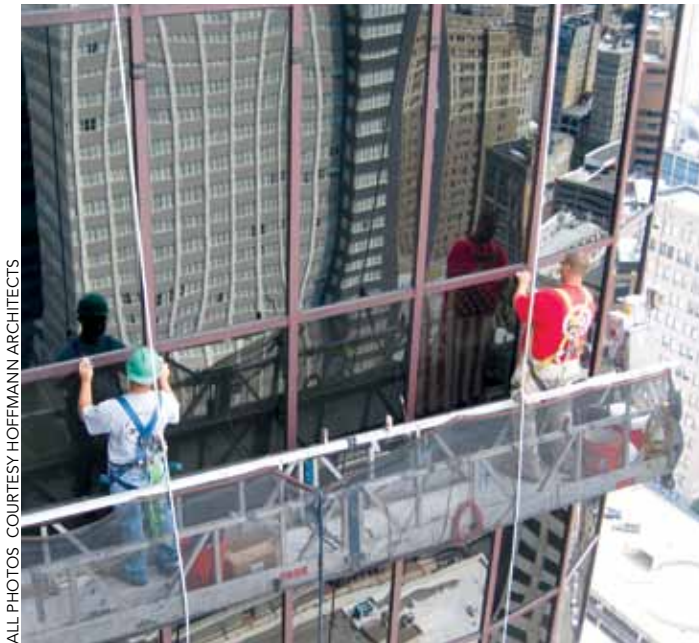
Workers repair a failed glass curtain wall. “As glazed curtain walls age, many of their components may reach the end of their service lives,” say the authors. Then, leaks and drafts may become recurrent problems.

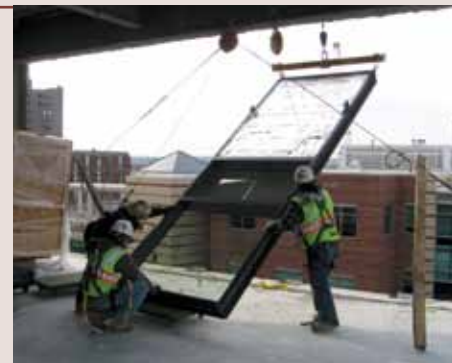
**Laminated glass** bonds two or more sheets of glass to an interlayer of plastic, generally

polyvinyl butyral (PVB), which holds the glass in place if broken. Laminated glass is often specified for curtain walls in hurricane-prone regions or in areas requiring blast protection.

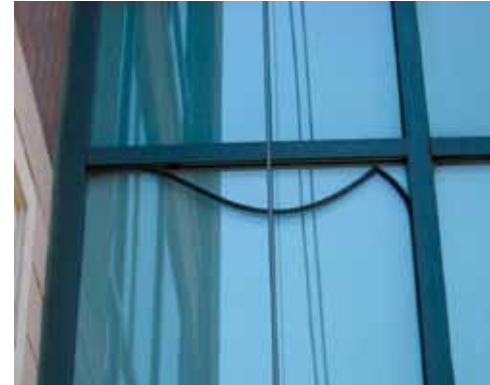
Loose gaskets or seals.

**3. Gasket and seal degradation.** A common cause of curtain wall problems is failure of the gaskets and seals that secure the glazing. Gaskets are strips of synthetic rubber or plastic compressed between the glazing and the frame, forming a watertight seal. Gaskets also serve to cushion the glass and to accommodate movement due to wind, thermal, or seismic loads.

As they age, gaskets begin to dry out, shrink, and crack. Subjected to ultraviolet radiation and freeze-thaw cycles, the elastic material degrades, much like an old rubber band. At first, air spaces created by the shrinking, dried gaskets admit air and moisture into the system, leading to condensation, drafts, and leaks. As the gaskets further disintegrate, they may loosen and pull away from the frame. Without the support of flexible gaskets, the glass loses stability and may shatter or blow out. For this reason, it is important to maintain and routinely replace gaskets to keep the curtain wall system operational and safe.

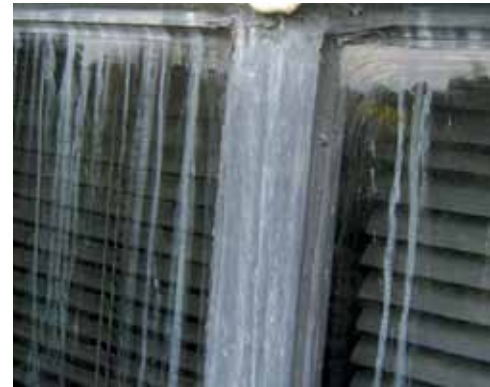
Streaked glazing.

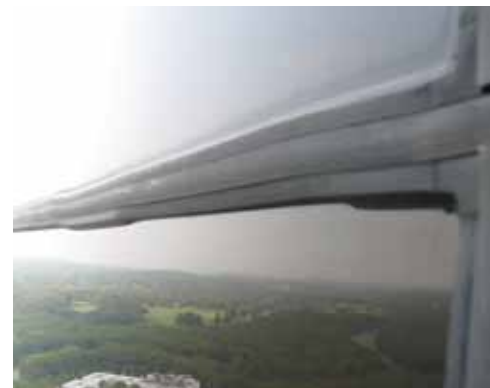
Gaskets disengaged from glazing.

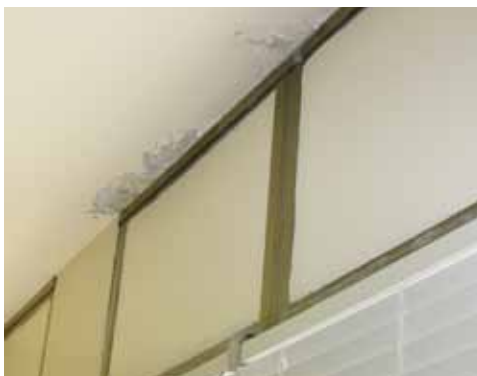
Leaks and drafts in curtain wall assembly.

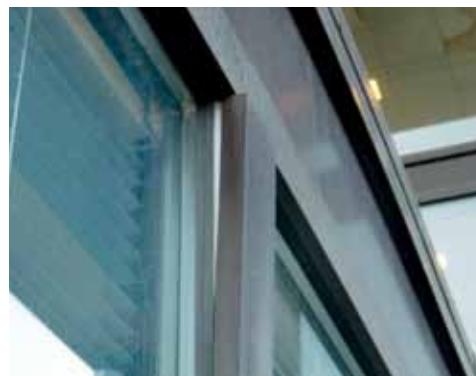
Displaced mullion covers.

*Poorly installed trim covers and accessories* can pose a danger to people and property below, particularly when adhered using structural glazing tape alone, without mechanical attachments. Construction sequencing is of particular importance, as swing staging and scaffolding can damage or displace mullion covers. Maintenance activities may also be responsible for loose trim elements.

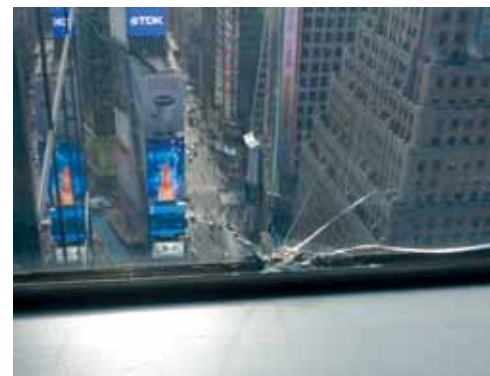
Broken glass in glazed curtain wall.

Nickel sulfide (NiS) inclusions can cause glass to shatter suddenly, sometimes years after installation. All glass has microscopic imperfections, or inclusions, that result from the manufacturing process. Generally speaking, these are of little concern. The exception is NiS inclusions in tempered glass, which have led to a number of dramatic glass failures. As glass is heated during the tempering process, NiS converts to a compressed (alpha) phase. When the glass is cooled rapidly to temper it, the NiS lacks sufficient time to return to a stable low-temperature (beta) phase. Over months or years, the trapped NiS transitions to the beta phase, expanding as it does so. The resultant pressure leads to microcracks in the glass, which can propagate until the glass structure is thoroughly compromised, and the glass shatters in what seems to be a spontaneous breakage.

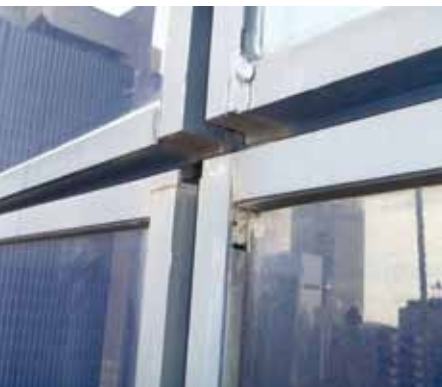
Gaps at frame corners.

Missing, incorrectly applied, or otherwise *deficient sealants* at frame corners and other intersections can lead to serious water infiltration problems. Failure on the part of the contractor to follow manufacturers' guidelines, or on the part of the design professional to provide sufficient oversight, can result in water damage that is both difficult to access and expensive to repair.

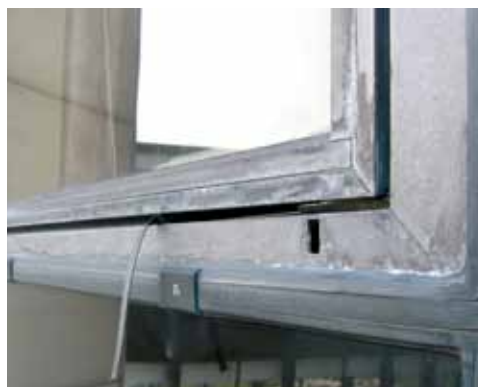
Loose or missing weather stripping.

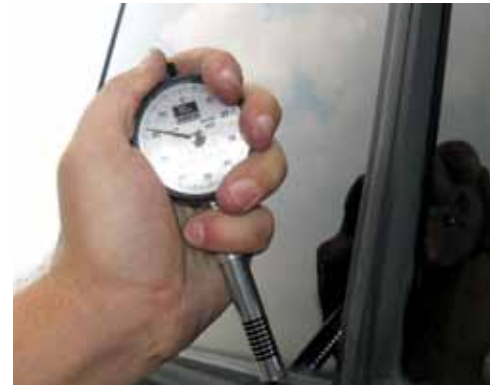
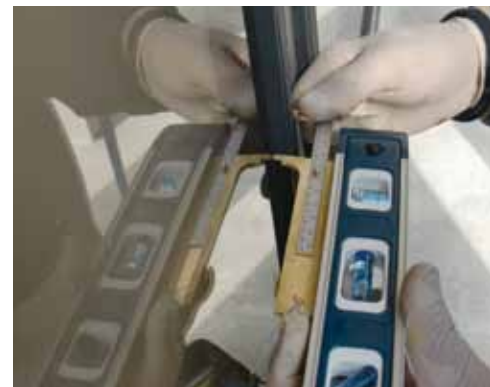
Evaluation may include measurement of gasket hardness (top) and glazing alignment (above). Glazing that exhibits systematic scratches or defects may need to be evaluated for structural integrity under laboratory conditions, the authors warn.

Glazing that displays systematic scratches or other defects after installation may need to be evaluated for structural integrity. In such cases, a representative sample of glass units may be removed and tested under laboratory conditions. ASTM E997 is one test method for determining the probability of breakage for a given design load.

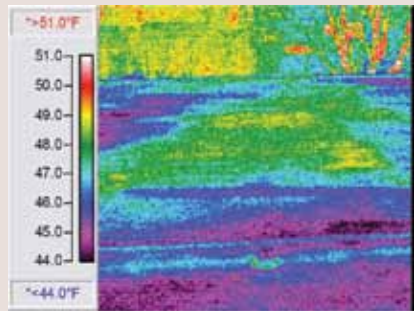
Infrared analysis can locate thermal anomalies caused by such factors as missing thermal breaks, air or moisture infiltration, or "hot spots" where mechanical or electrical equipment is malfunctioning. Thermography is noninvasive and can be performed during normal building hours. Using temperature scanners, the test generates pictorial representations of a building component's thermal profile. Correct analysis of this data can reveal problems not otherwise identifiable on an existing, occupied structure.

However, accurate interpretation of thermal images demands understanding of building envelope composition. Certain types of construction tend to dissipate heat, leading to false negative readings, whereas others reflect heat and generate false positives. In the right hands, thermographic testing can be a useful diagnostic tool. When incorporated into a comprehensive condition assessment, infrared analysis can save resources by prioritizing renovation efforts and avoiding unnecessary repairs.
