STOREFRONT REHABILITATION AND DESIGN

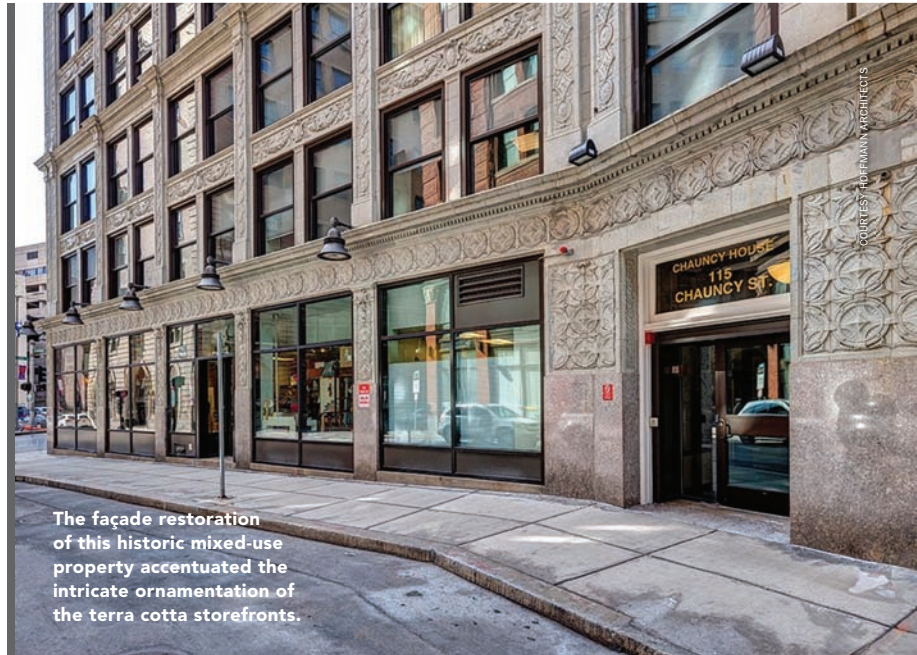
The façade restoration of this historic mixed-use property accentuated the intricate ornamentation of the terra cotta storefronts.

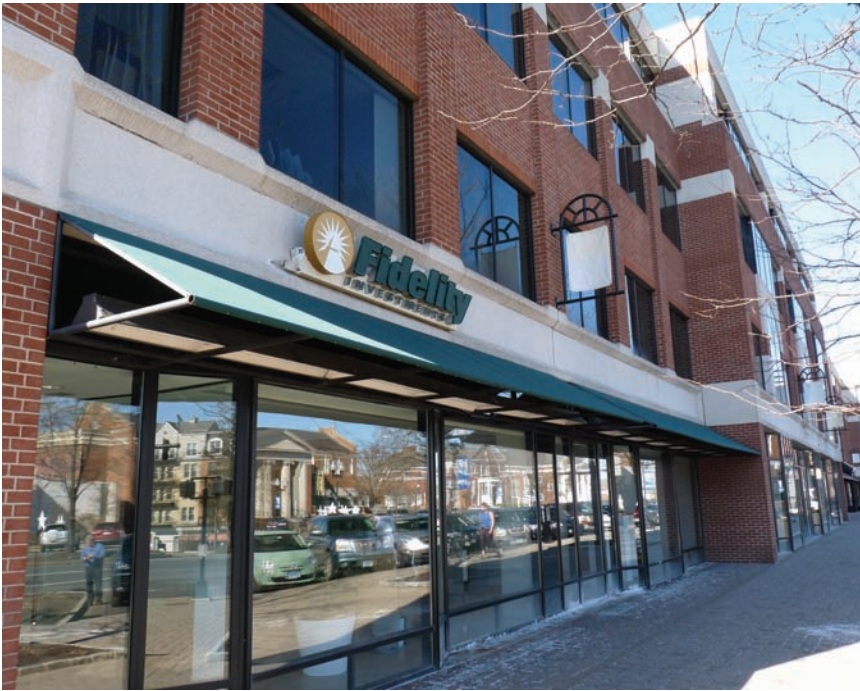
Leaks at windows, doors, and along the base of walls may be temporarily addressed with stopgap measures, but eventually full replacement of a poorly performing storefront assembly may be necessary.

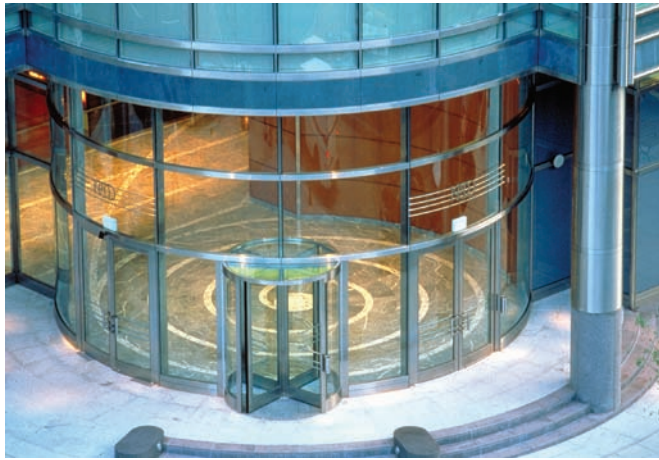
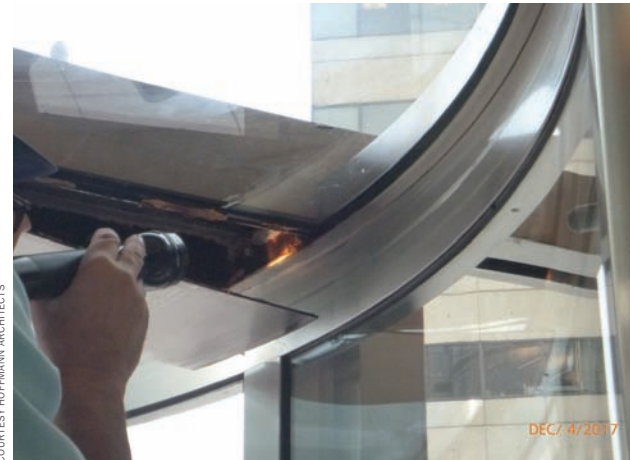
Investigation of the poorly functioning revolving door at this office complex revealed extensive corrosion.

• **Revolving doors.** For buildings with significant traffic, such as commercial buildings, hotels, shopping malls, and hospitals, revolving doors can mitigate strong positive and negative pressures. Where HVAC and outdoor conditions would cause excessive wear and tear on a typical door, revolving doors permit high-volume usage without compromising indoor climate. Automatic revolving doors provide ADA-compliant operation while managing heavy traffic.

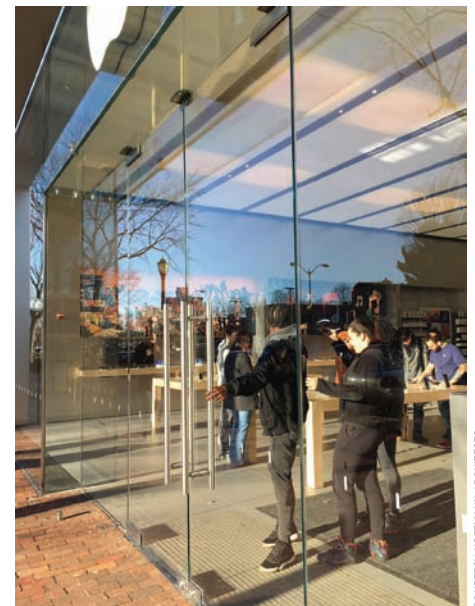
Without weatherstripping, these doors look sleek, but air infiltration may be an issue.

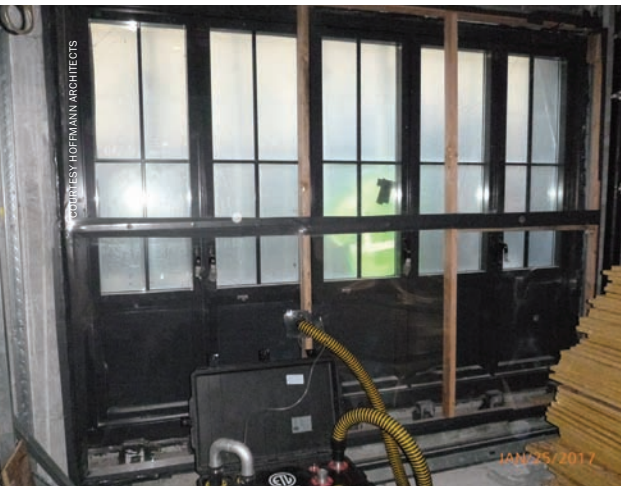
Field tests confirm the storefront meets performance standards.

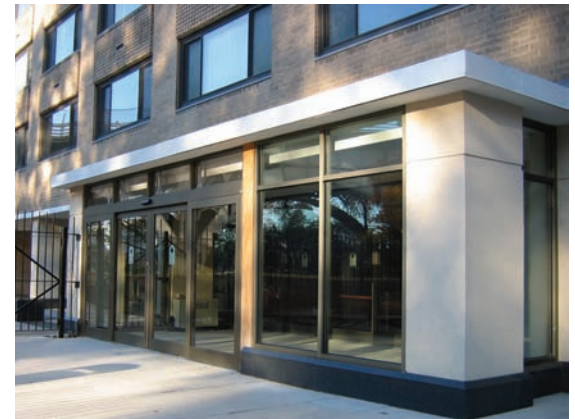
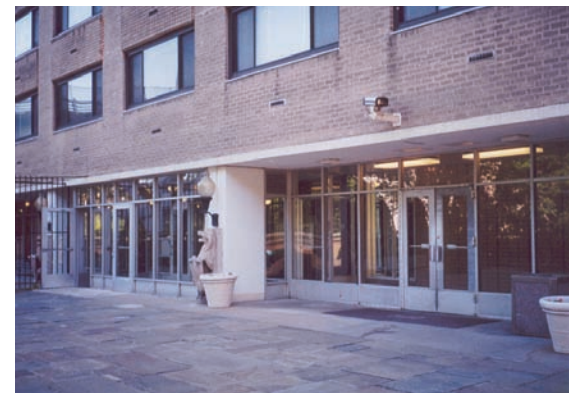
Replacement of this aging storefront demanded modifications to the new assembly for operation in strong wind.

subjected to strong forces when open, taxing the hardware and leading to constant maintenance repairs or replacement. In this location, a balanced door, while more expensive at the outset, might prove less costly in the long term, as its resistance to wind pressure could mean longer lifespan and fewer repairs.

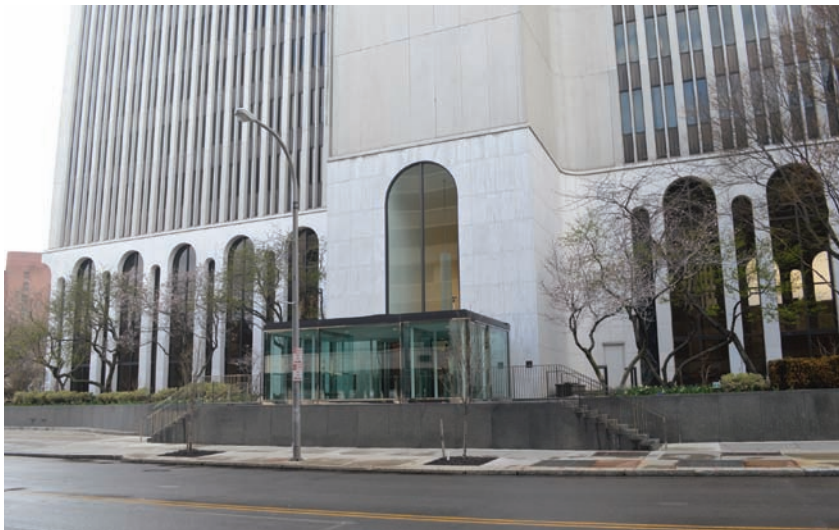
The award-winning storefront entrance redesign at this Modern-era landmark maintained the aesthetic of the original while improving thermal regulation and pedestrian traffic flow.
